**COMPLIANCE CRASH TESTING OF THE TYPE 60K  
CONCRETE BARRIER USED IN SEMI-PERMANENT  
INSTALLATIONS**

FINAL REPORT # FHWA/CA/TL-2001/08  
CALTRANS STUDY # 680841

August, 2001

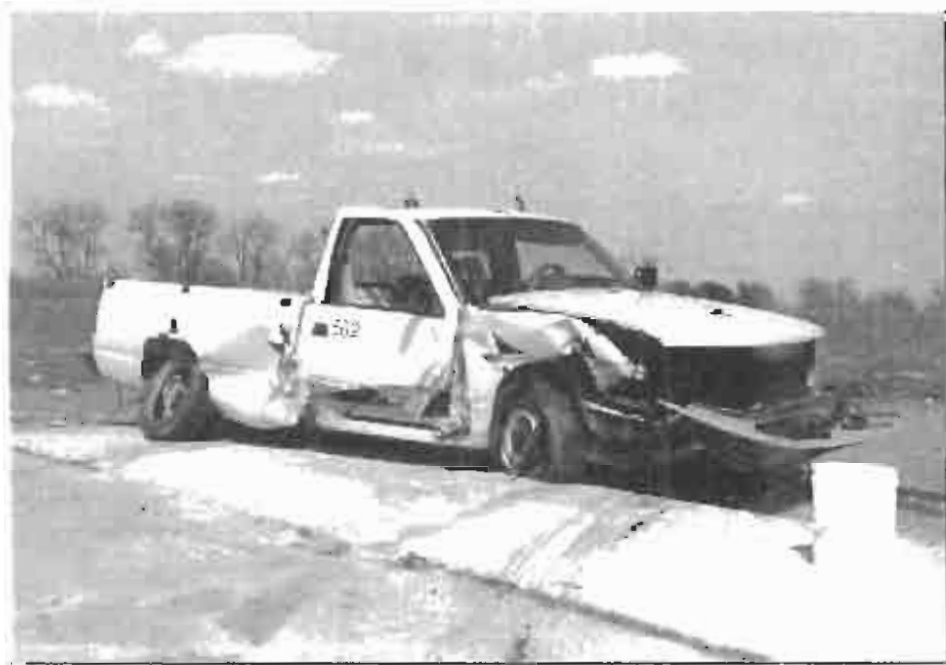
Most of the damage to the vehicle was on the front half of the right side (Figure 2-1). The right third of the bumper was pushed back into the front right wheel well. The front tire was

The floor deformation at the center of the front passenger side of the vehicle was about 115 mm. At the firewall, the maximum floor deformation was 135 mm.

Figure 2-1 – Test 562. Overall damage to the vehicle

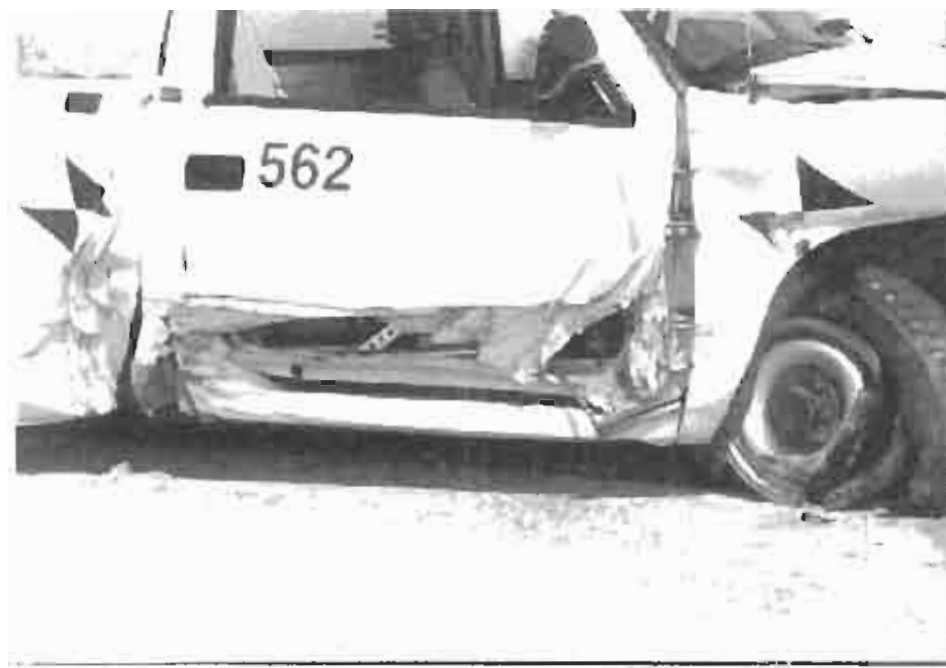
Figure 2-2 – Test 562. Damage to the vehicle door

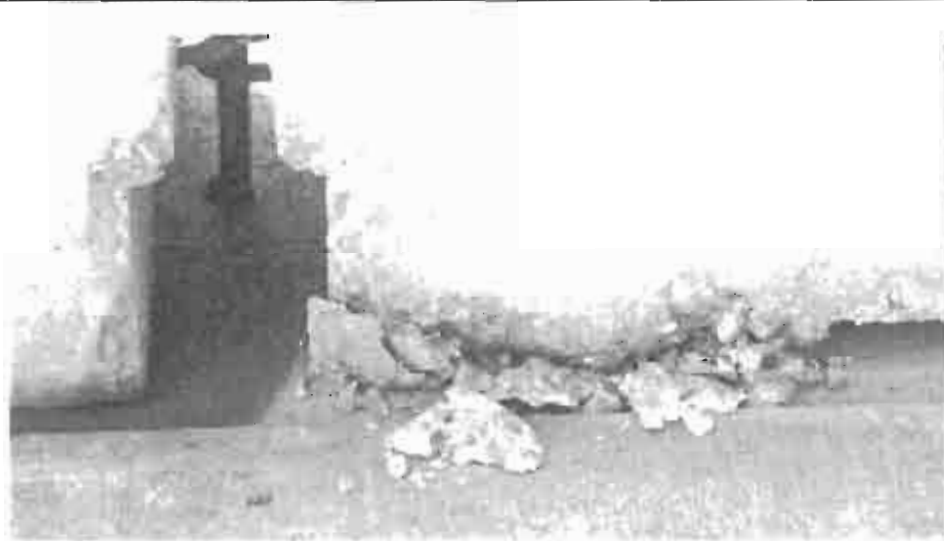
Figure 2-3 shows the spalled concrete at the base of segment 8, one joint upstream of impact. The steel angle lining the sides of the trough acted to cut the barrier along the backside of the segments that were laterally deflected.

Figure 2-3 – Test 562. Segment 8 at Joint 7-8

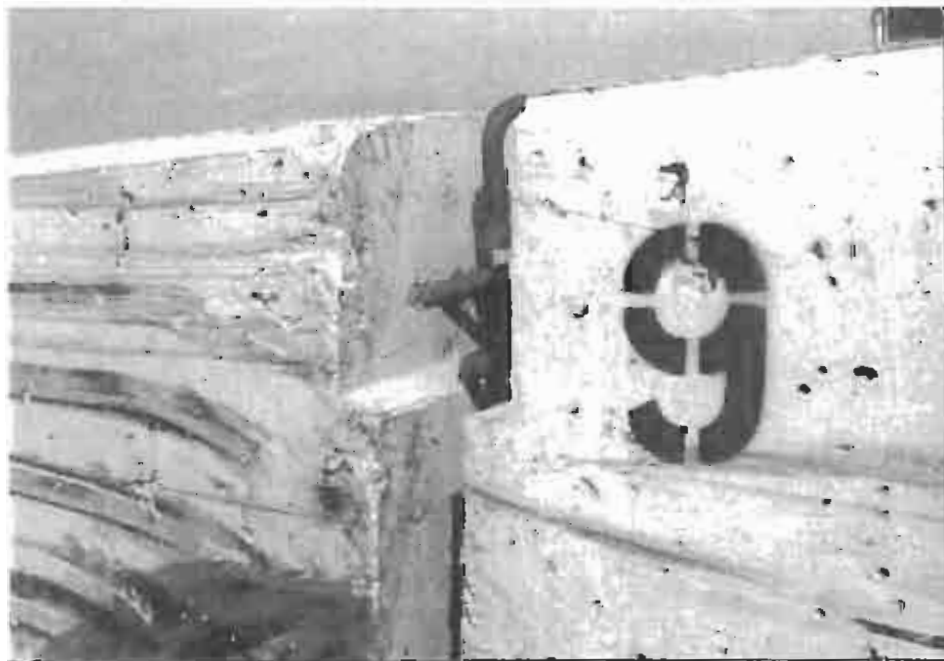
Illustrating the snagging potential of the Type 60K-v1. Figure 2-4 shows the scuff marks on the end face of segment 10 where the vehicle penetrated the barrier face.

Figure 2-4 - Test 562. Segments 9 and 10

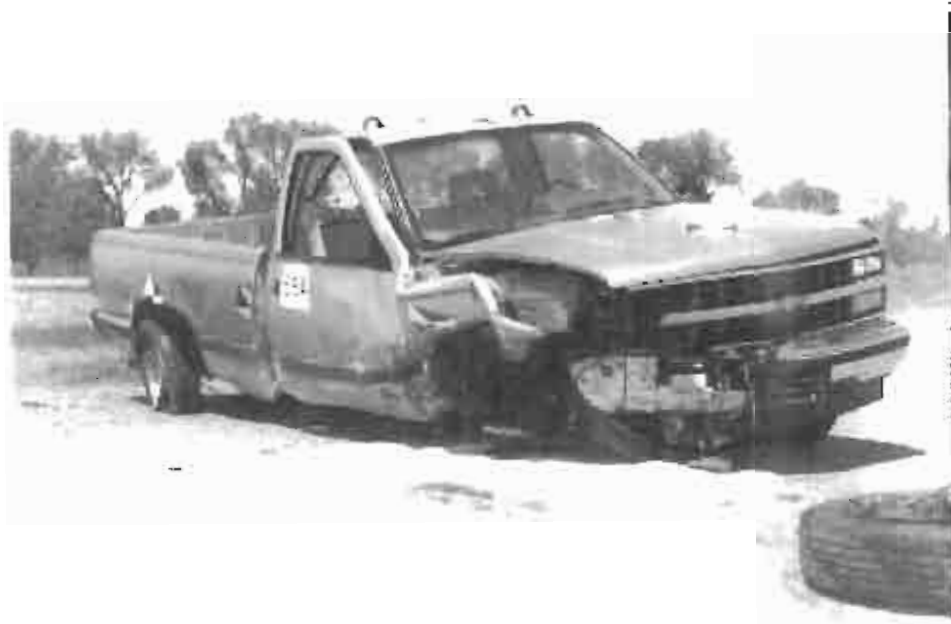
Vehicle damage was extensive. The right front wheel, hub and spindle assemblies were sheared from the suspension. The right A-arm was bent back and twisted. The right side of the front bumper was pushed back approximately 510 mm (see Figure 2-6). The right front fender and inner fender were pushed in and back against the engine. The right frame rail was bent into the engine and the engine was tilted up on the right side. The radiator, transmission cooler, battery box and battery received extensive damage.

Figure 2-6 – Test 564. Damage to the front of the vehicle

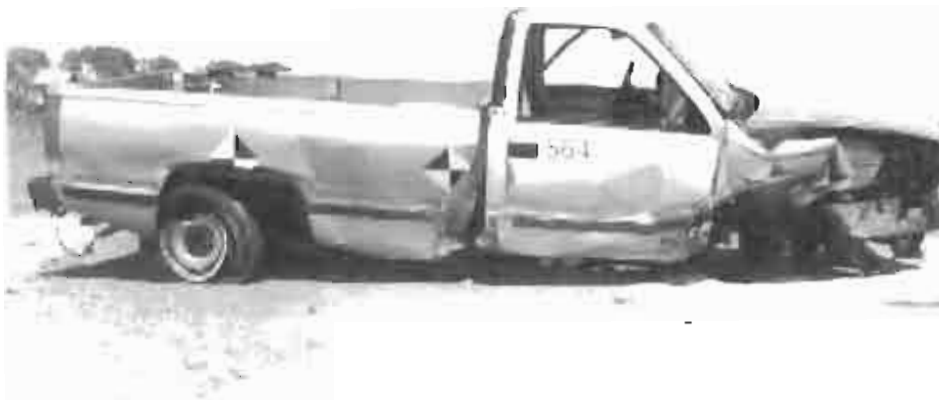
The right rear of the vehicle also received extensive damage (see Figure 2-7). The right side of the bed was dented the full length and the whole bed was shifted to the left on the frame. The rear axle broke loose from the suspension, and was pushed back approximately 600 mm. The axle housing bent and the differential housing broke. Both of the right side tires were flat and ruptured with extensive damage to both wheels.

Figure 2-7 – Test 564. Damage to the side of the vehicle

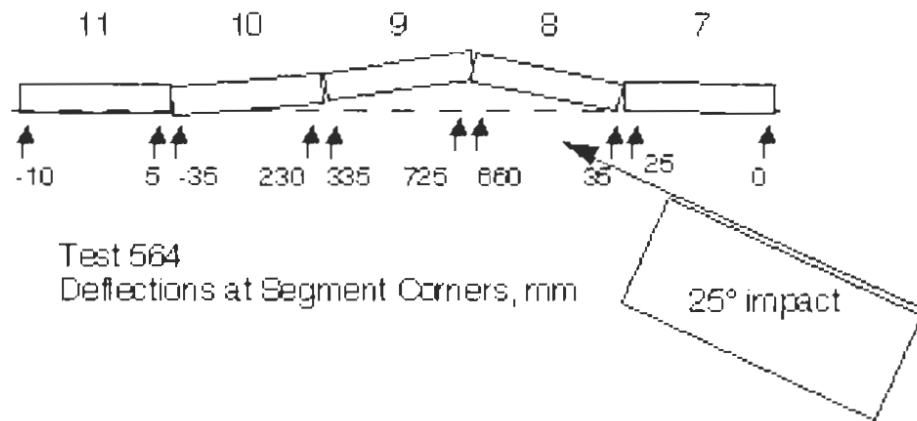
Figure 2-8 – Test 564. Barrier deflections

Damage to the barrier was limited to barrier deflection, two of the connection pins being pulled out of the pavement, and some minor concrete spalling. The maximum, permanent barrier deflection was 725 mm at the joint between segments 8 and 9 (see Figure 2-8). The barrier deflections led to the pins at joints 8-9 and 9-10 being pulled out of the pavement. Concrete spalling was limited to the leading edges of segments 8 and 10 where the vehicle snagged the barrier. All of the barrier segments were reusable

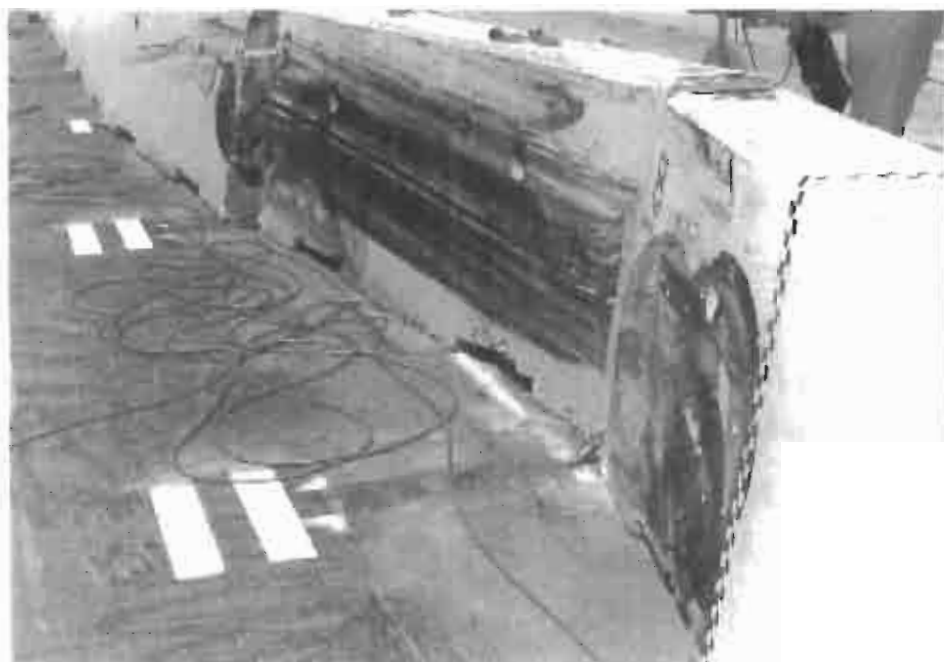
Figure 2-9 – Test 564. Deflection and tire marks

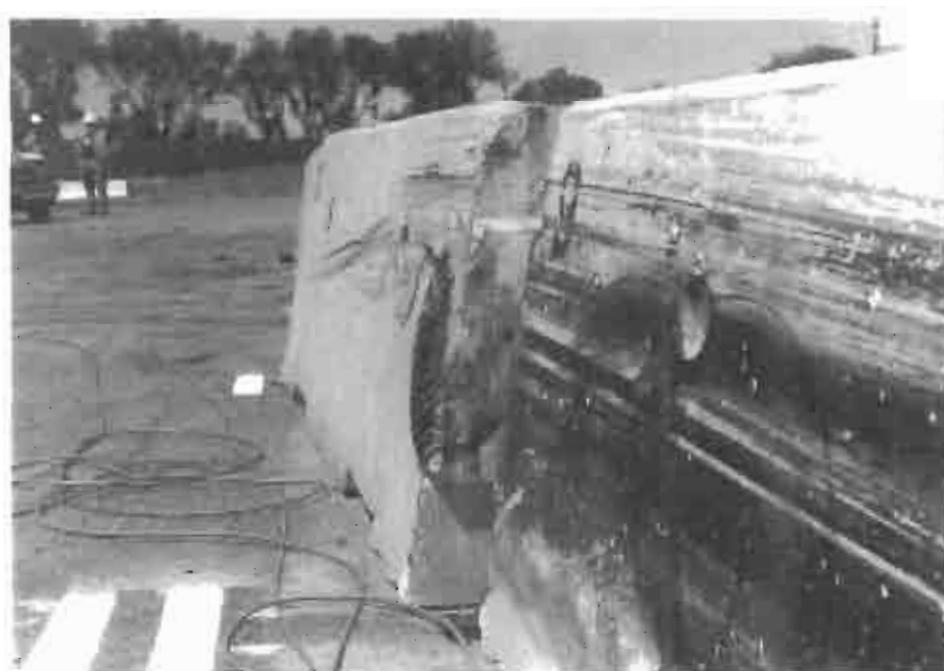
Figure 2-10 – Test 564. Snag at joint 9-10

60K-v2: The structural adequacy of the 60K-v2 was also unacceptable. Test 564 showed that the differential rotation of the barrier segments and consequential vehicle snagging at the barrier joints was even more pronounced than in the test of 60K-v1. During the time of contact between the test vehicles and the barriers there were minor amounts of scraping and spalling.

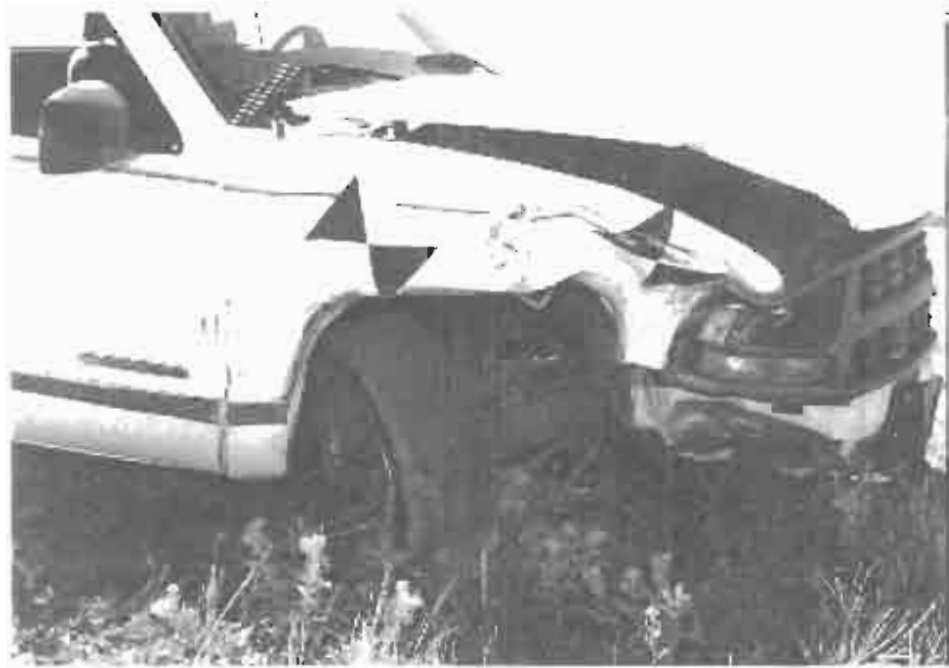
Most of the damage to the vehicle was confined to the front right corner, with additional damage along the impacting side of the vehicle (see Figure 2-12 and Figure 2-13). The front right tire was torn, but still on the vehicle. The corner panel and the far right side of the bumper were crushed. The tie-rod was severely bent. The hood was partly raised, but still latched. There were scuff-marks along the rear right side of the vehicle. The right rear wheel separated at the seam, allowing the tire and rim to detach from the vehicle. The engine was still functional.

Figure 2-12 – Test 565. Impacted corner of vehicle

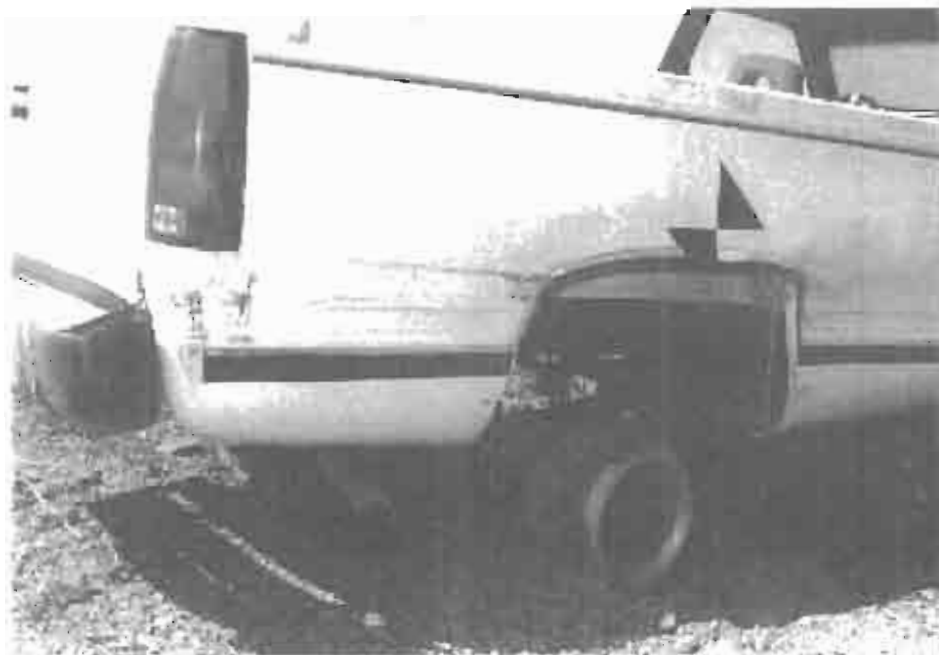
Figure 2-13 – Test 565. Damage to the back right of the vehicle

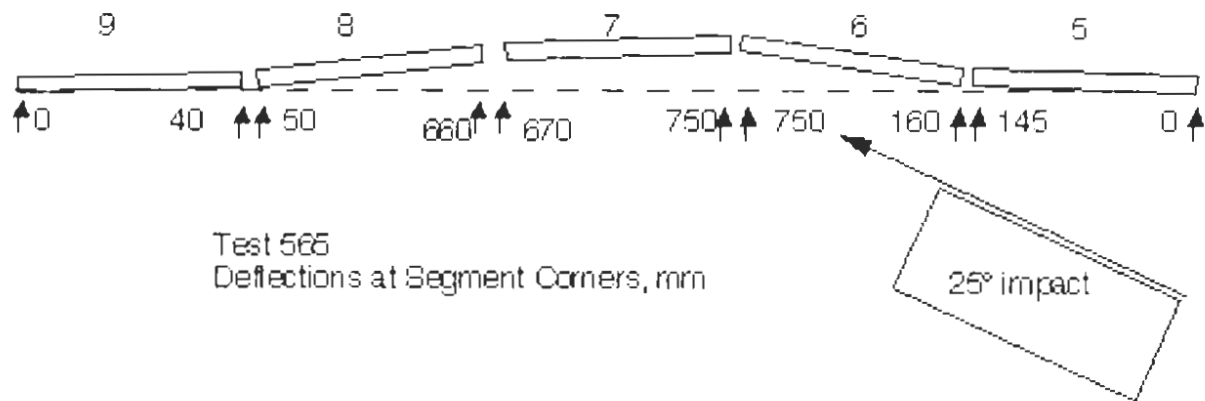
The barrier shifted a maximum of 750 mm at the impacted joint during impact.

Figure 2-14 – Test 565. Barrier deflections

Damage to the barrier was limited to shifted segments, minor concrete spalling, bent connecting pins, and scuffing of the concrete face. Out of the 12 segments making up this barrier, only segments 1, 2, and 12 did not move. Segments 5, 6, 7, 8, and 9 had measurable lateral deflections. The spalling concrete occurred at joint 6-7 where the concrete is the thinnest. The connecting pins nearest the impact were bent, six of which had to be cut. All of the barrier segments were reusable.

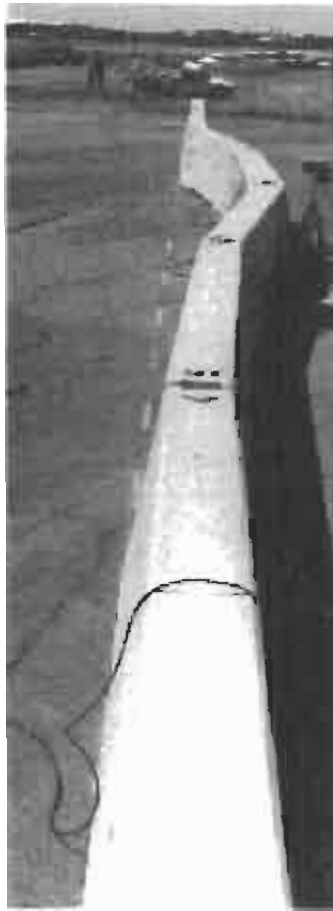
Figure 2-15 – Test 565. Lateral deflections

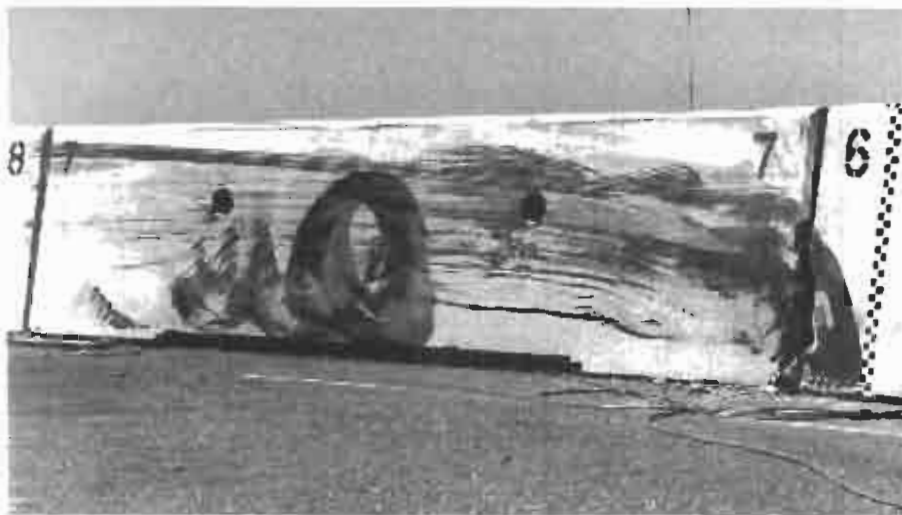
Figure 2-16 – Test 565. Tire marks

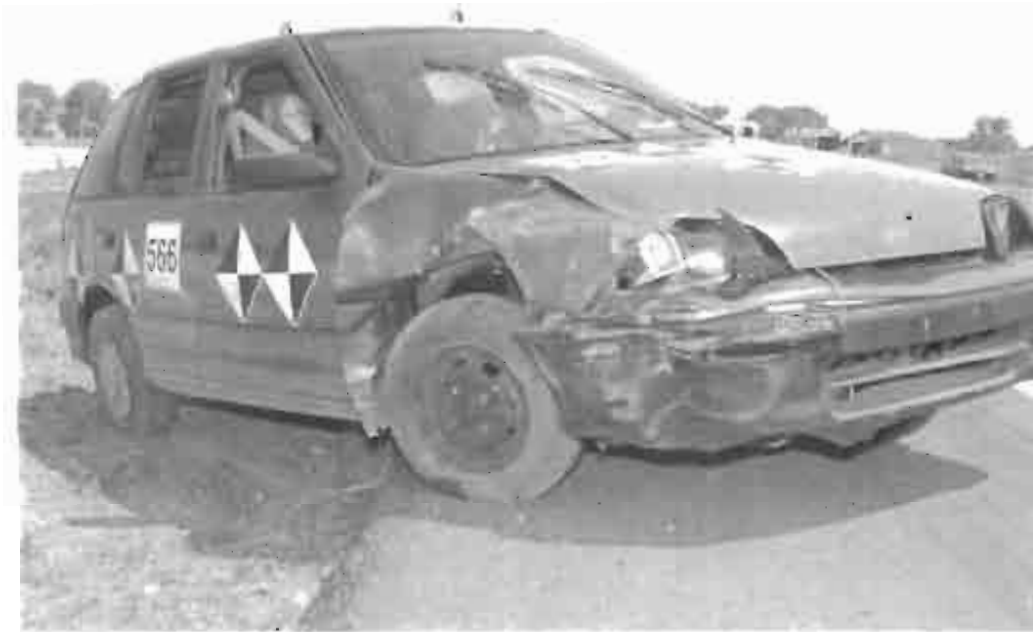
Most of the vehicle damage was limited to the front right corner of the vehicle. The corner panel was crushed and the hood had been buckled. The front right wheel was turned inward. The steering mechanism was damaged but the steering wheel could still turn the wheels. The tire was still inflated. The hubcap was missing from the front right wheel.

Figure 2-18 – Test 566. Vehicle damage to the impacted corner

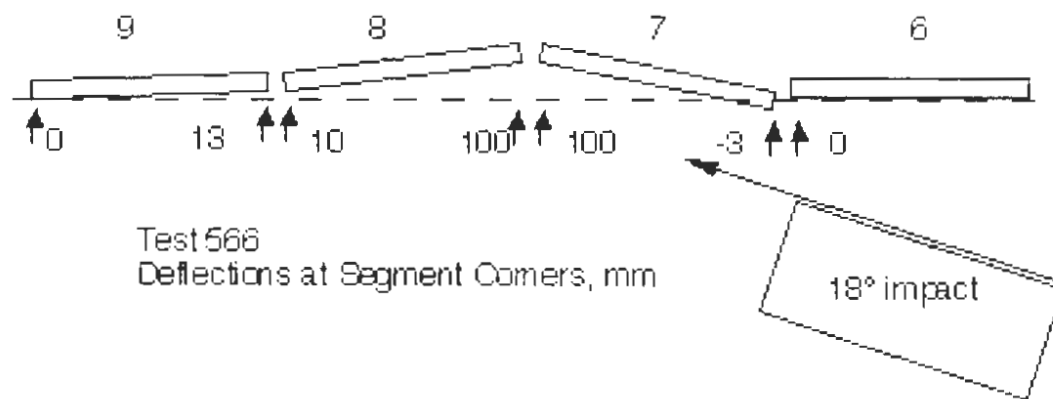
The barrier shifted a maximum of 100 mm during impact.

Figure 2-19 – Test 566. Barrier deflections

Impact occurred on segment 8, 535 mm downstream from joint 7-8. Damage was limited to scuffing on the face of segment 8 only. Although the connecting pins were slightly snug, they could be pulled out using a pry bar.

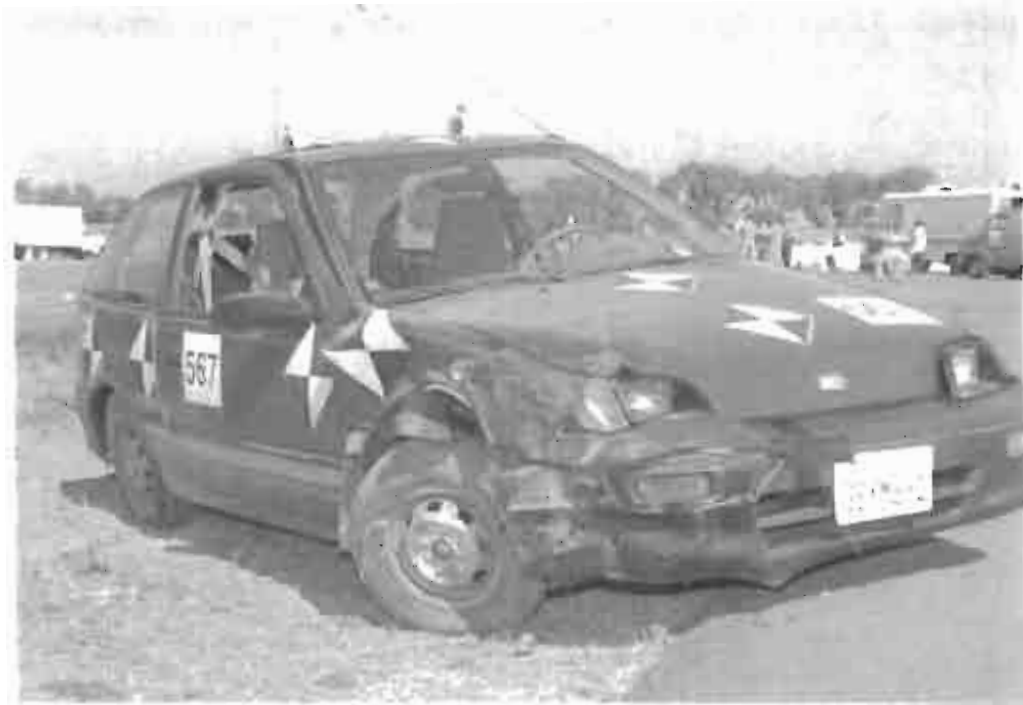
The damage to the test vehicle was similar to the vehicle damage in test 566. Most of the damage was limited to the front right corner of the vehicle. The corner panel was crushed and the hood had a small dent. The right 300 mm of the front bumper was pushed back 150 mm into the wheel well. The front right wheel was turned inward more severely than in test 566 and the hubcap was lost. The steering mechanism was damaged but the steering wheel could still turn the wheels. The tire was still inflated.

Figure 2-21 - Test 567. Damage to the impacted corner of the vehicle

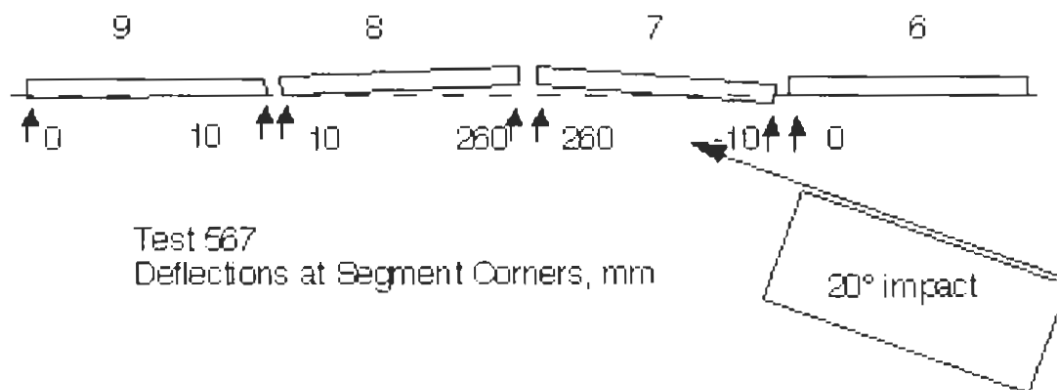
The barrier shifted a maximum of 260 mm during impact.

Figure 2-22 - Test 566. Barrier deflections

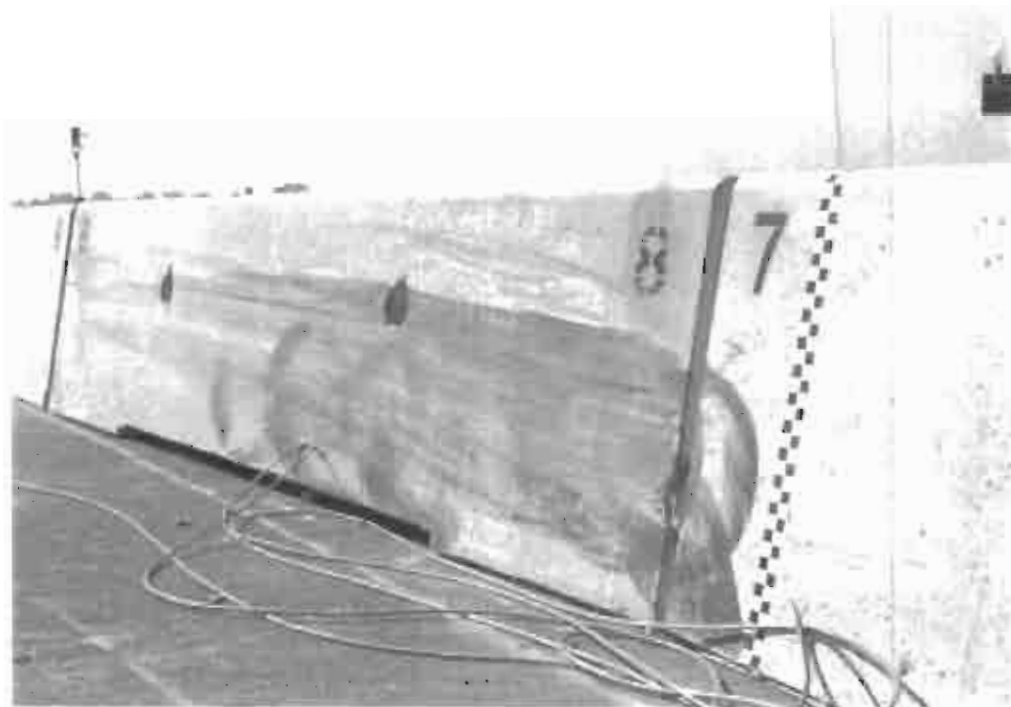
Impact occurred on segment 7, 100 mm upstream from joint 7-8. Segments 7 and 8 received some scuffing during contact with the test vehicle. Segment 8 received some minor spalling at

its leading edge. As in Test 566, the connecting pins were slightly snug, but could be pulled out using a pry bar.

Figure 2-23 – Test 567. Scuffing and lateral deflection of barrier
